D-Day

TANK WARFARE

ARMORED COMBAT IN THE NORMANDY CAMPAIGN JUNE-AUGUST 1944

Steven J. Zaloga and George Balin

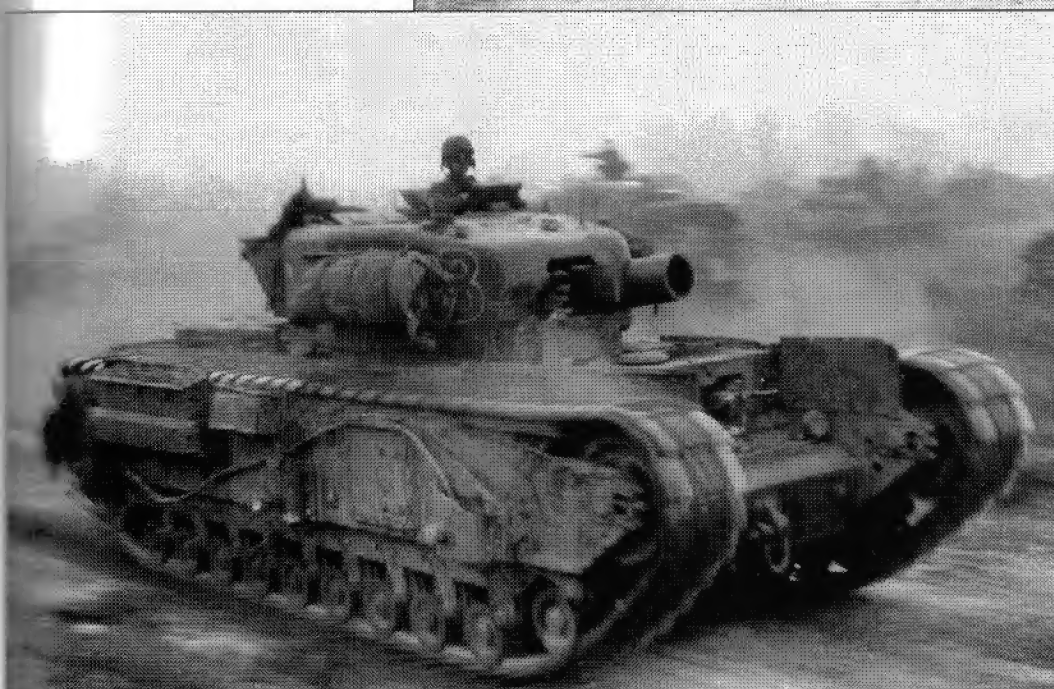
A Churchill IV AVRE barreling along a road in Normandy. The AVRE version of the Churchill is easily distinguished by the enormous bore of the Petard launcher mounted on the turret front. The Churchill was generally popular in the British tank brigades because of its thick armor, but it was slow and underpowered compared to other Allied tanks. Unlike the Sherman, none were upgunned with the 17 pdr., which limited the effectiveness of Churchills in tank-vs.-tank combat. (The Tank Museum)

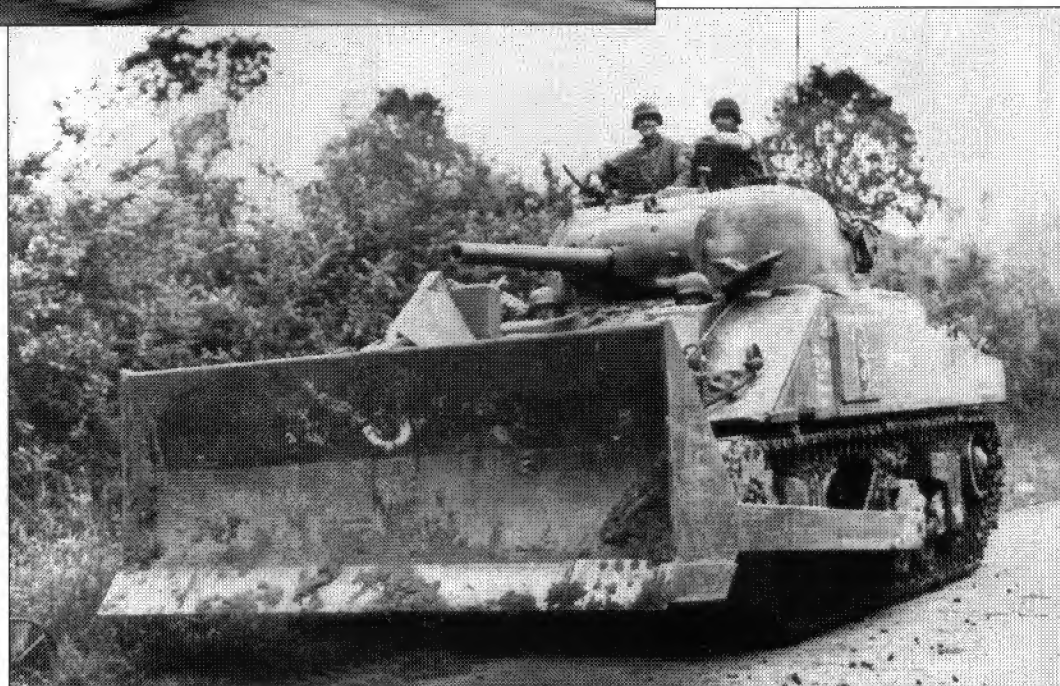
A M4 dozer tank named "Apache" of Company A, 70th Tank Battalion in the area beyond Utah beach in June 1944. The M1 bulldozer kit was one of the few US Army engineering innovations used at Normandy. Besides proving useful in the invasion itself, the dozer tanks proved invaluable in the bocage fighting to help clear lanes through the thick hedgerows. (US Army)

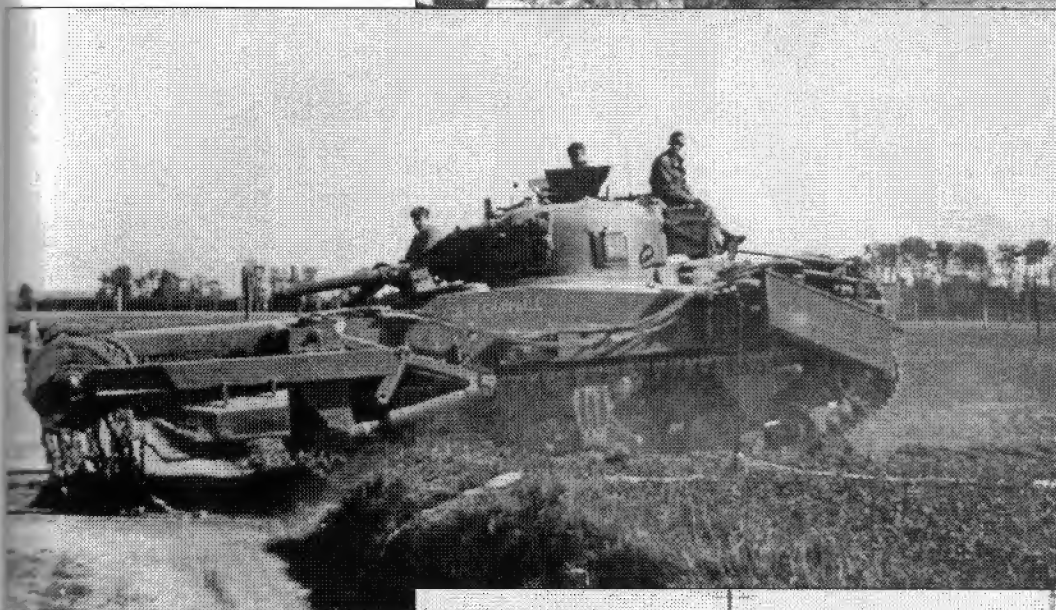
A Sherman Vc Firefly of the 4 RTR passes through a French village on 8 June. The tactical sign, a white 124 on a red square, was the characteristic numbering of a tank in an independent brigade rather than in one of the divisional armoured brigades. This photo clearly illustrates one of the other important changes made on the Firefly: the addition of a turret roof hatch for the loader. (The Tank Museum)

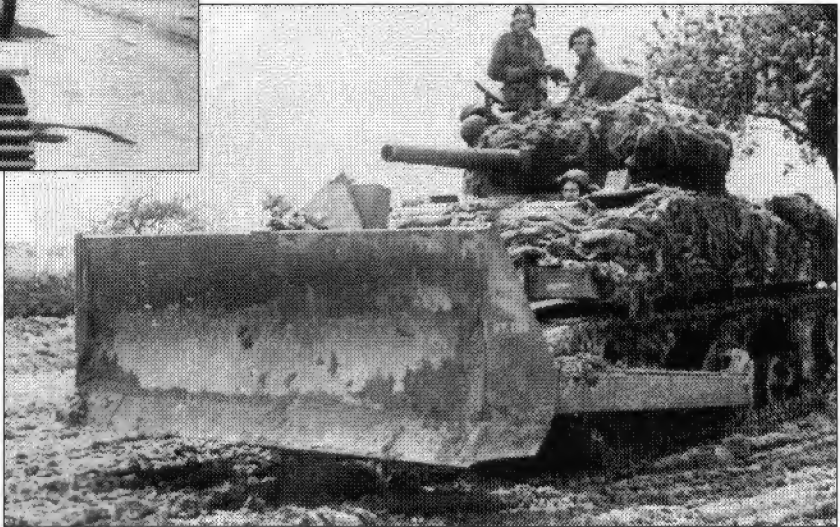
Although a common enough sight in US Army tank units, the Sherman with M1 dozer blade was far less common in British units as seen here. Note the tanker's helmets stowed outside the turret- a necessary substitute for the jaunty British tanker's beret in the Normandy fighting due to the presence of skilled German snipers. This Sherman V is well camouflaged with netting. (The Tank Museum)

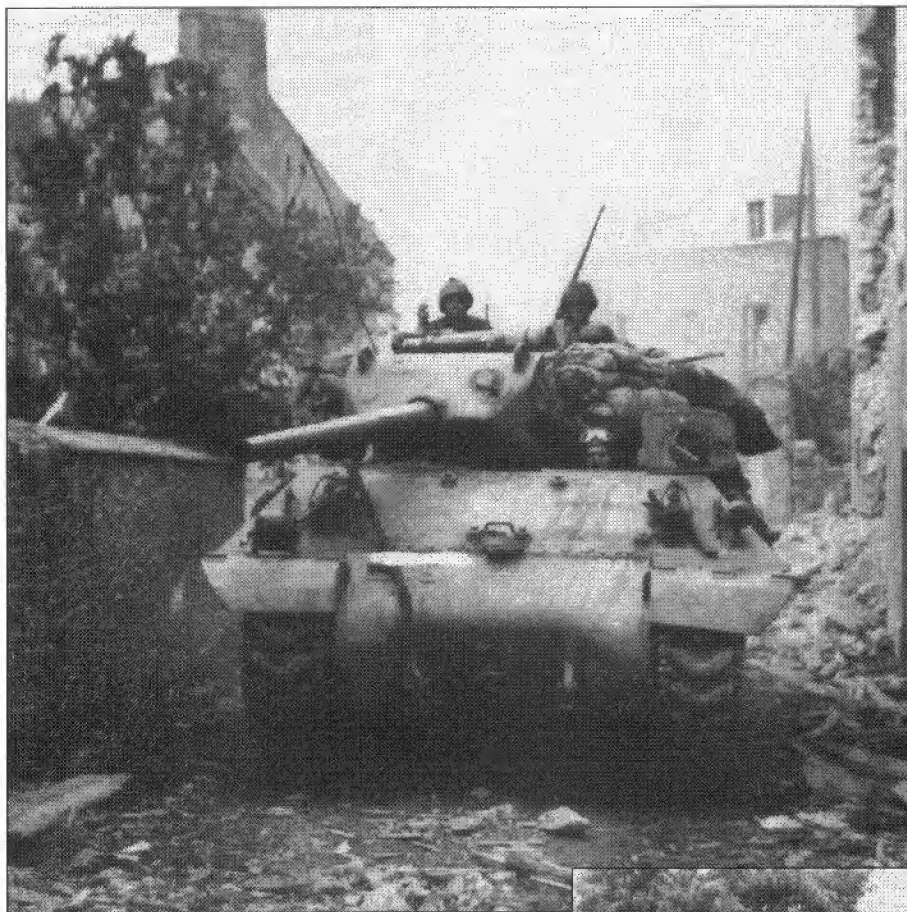
A US Army M10 3 inch tank destroyer, probably from the 823rd Tank Destroyer Bn., advances through the rubble of the town of St. Fromond on 7 July 1944 during the fighting towards St. Lo. St. Fromond was a road junction on the N174 road, and so the site of considerable fighting in early July as US Army units moved southwest out of the immediate bridgehead. This photo shows the traditional traveling mode of the M10, with the barrel traversed to the right so that the driver could keep his head popped out of the hatch. (US Army)

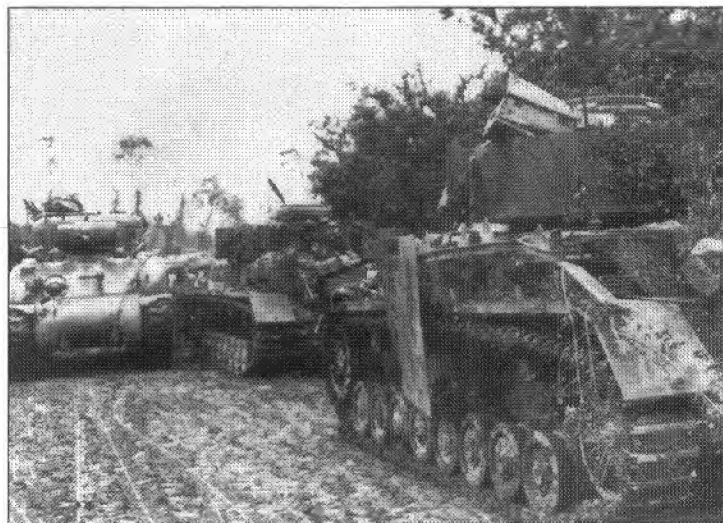
A M4A1 medium tank from 3rd Armored Div. passes along a pair of Pz.Kpfw. IV Ausf J tanks of 2.SS-Pz.Div. knocked out in the Vire river fighting north of St. Lo on 9 July. The side anti-bazooka skirts have been knocked off with only one left dangling on the side, but both tanks retain their foliage camouflage. The presence of Allied fighter bombers made foliage camouflage a daily necessity for German tankers in the Normandy fighting. (US Army)

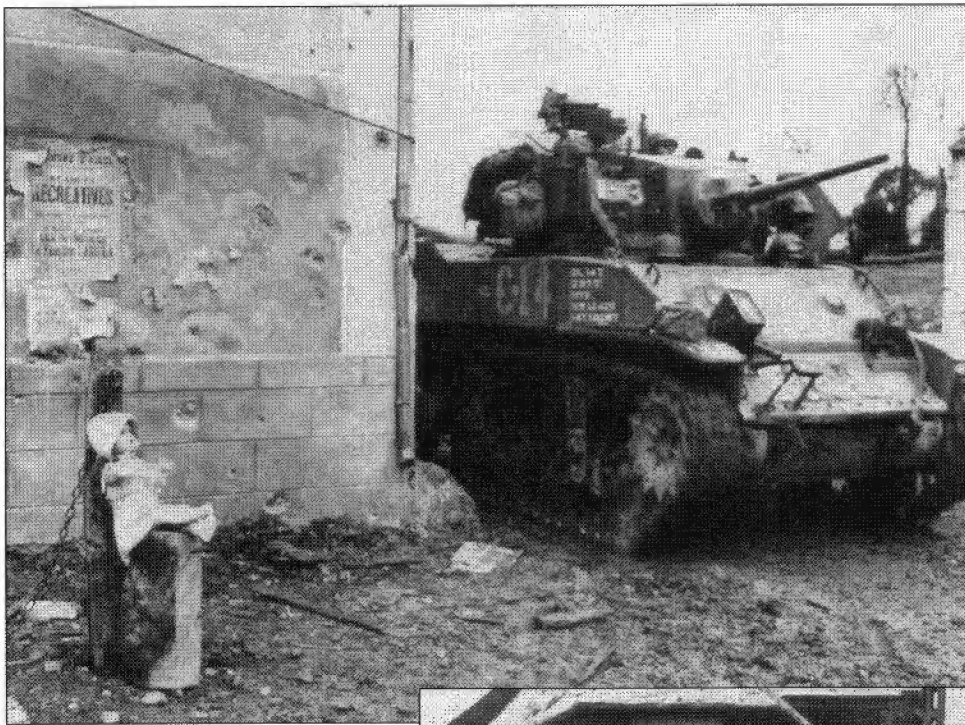
A M5A1 from Co. C, 33rd Arm'd Regt. passes a shell-pocked building in the town of Airel on 11 July, as US armor moved up to stop a German attack from Le Desert against the 9th Infantry Div. One of the curious details on this M5A1 is a device located below the hull machine gun. This is apparently a bullet deflector, added to the tank, which allowed the machine gun to be fired directly below the tank into trenches. (US Army)

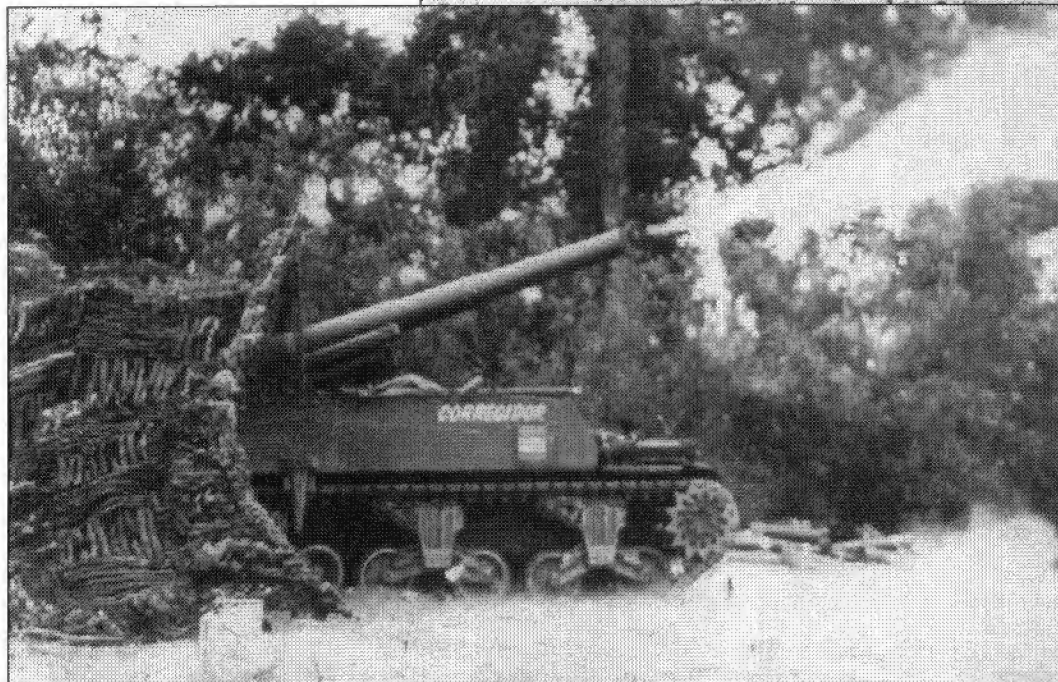
A M12 155mm gun motor carriage named "Corregidor" of the 987th Field Artillery Bn. fires in support of US forces near St. Lo in the Contentin fighting on 16 July. The M12 was a combination of a Sherman chassis with a World War I vintage French 155mm gun. The 987th was the only M12 unit in Normandy until 12 August when it was joined by the 587th and 588th FA Battalions. The M12 was replaced later in the European campaign by the more modern M40 155mm GMC. (The Tank Museum)

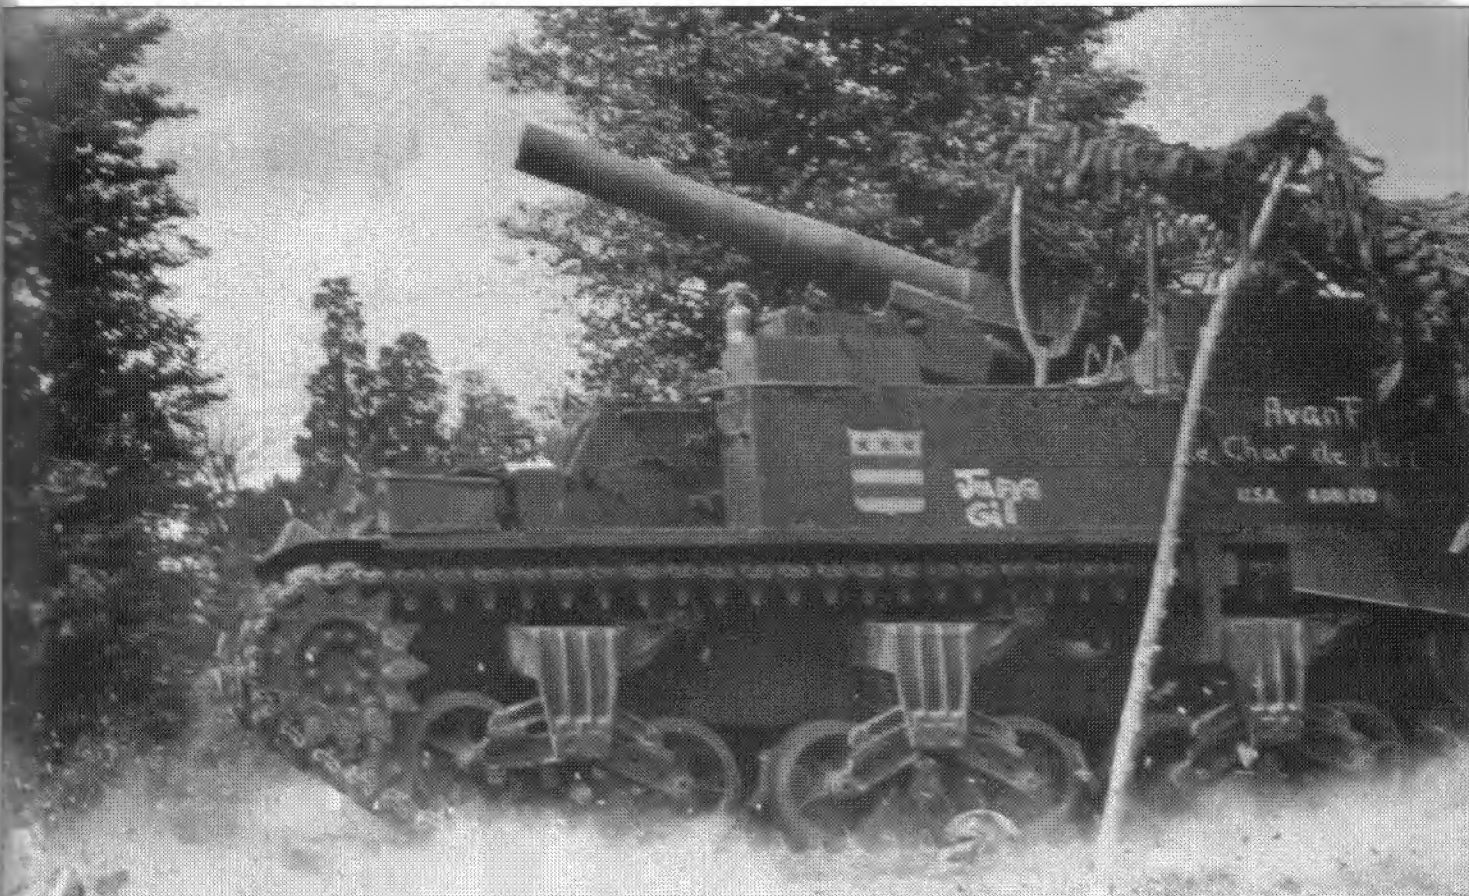
Another M12 of the 987th FA Bn. named "June Gil" in action on 16 July during the St. Lo fighting. It would appear that each battery of the battalion had a slightly different shield design on the hull side. The French inscription on the hull side: "Avant le char de mort!" means "Forward tank of death!".

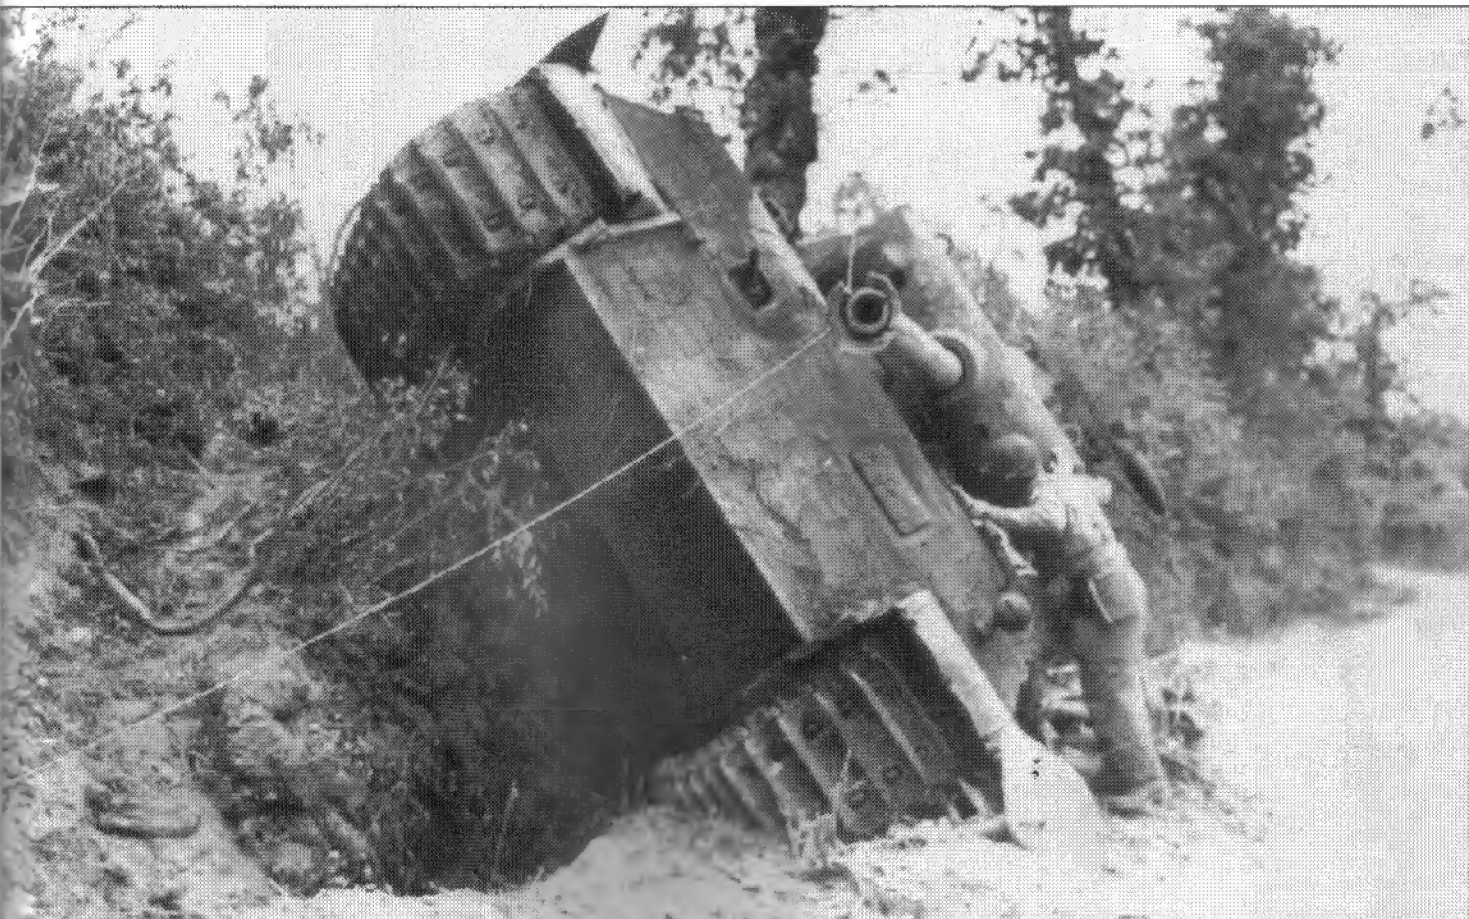
This Panther Ausf. A of 2.SS-Pz. Div. Das Reich was knocked out in fighting with the 22nd Infantry, 4th Infantry Div. during a skirmish near Sainteny on 16 July. The 4th Infantry was one of the two original US infantry divisions to have landed on D-Day, and spent nearly a week of bitter fighting against troops of the 2.SS-Panzer Div. in the hedgerows near Sainteny. (US Army)

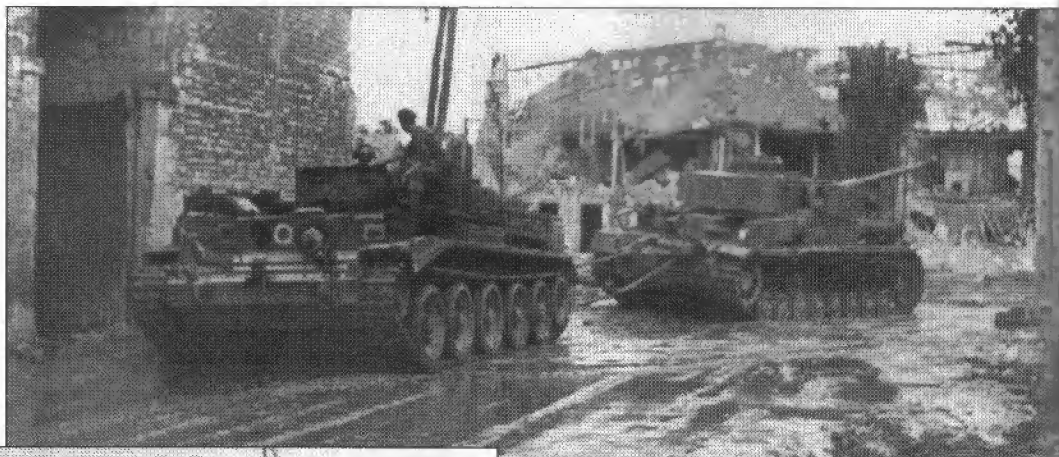
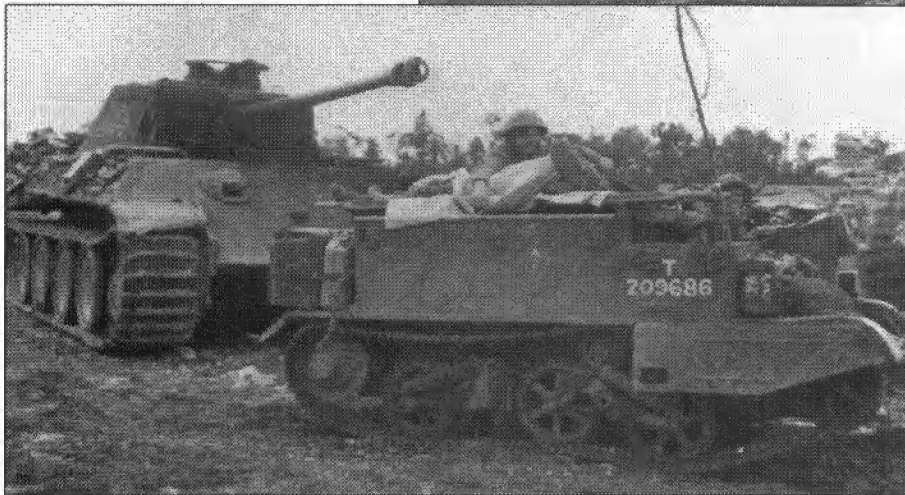
A Universal Carrier being used as an ambulance by the Durham Light Infantry passes by a knocked out Panther Ausf. A near the junction of routes D139 and 173a. This was one of the Panthers of 12.SS-Pz.Div. (Hitlerjugend) which was knocked out by a hit on the left rear side which set its fuel on fire during fighting in late June with the Canadians. (The Tank Museum)

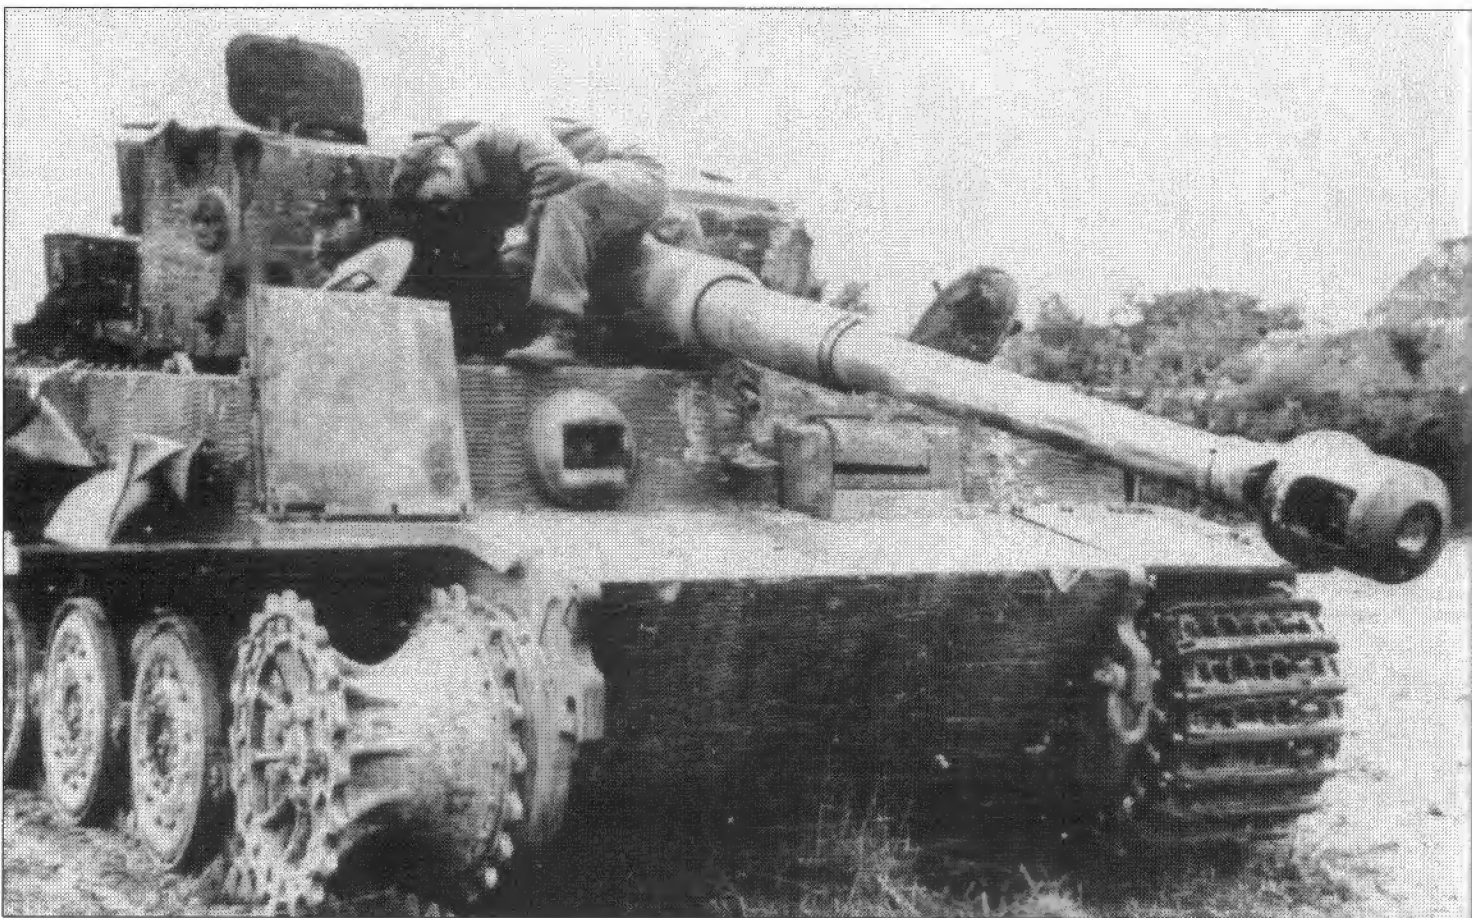
A Tiger I is inspected near Caen by a British soldier. The Tiger was the most deadly nemesis of British armor in the Caen fighting, and both German heavy tank battalions operated in the British and Canadian sectors, most memorably around Hill 112. This is a late production type with steel-rimmed road wheels, and has obviously suffered an internal ammunition explosion. (The Tank Museum)

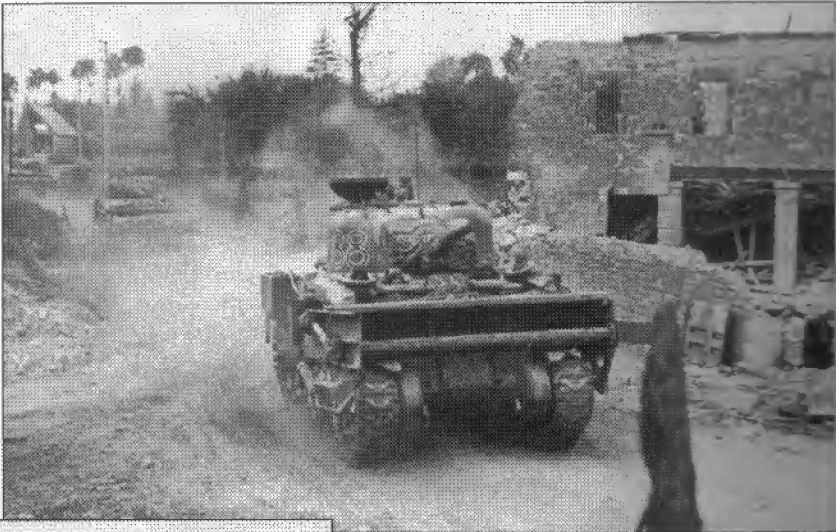
Instead of the improvised SBG bridges used by the 79th Armoured Division on D-Day, the Churchill tank brigades in Normandy were provided with the more refined Churchill Bridgelayers seen here. These were issued on a scale of one troop of three bridgelayers per brigade HQ. They were used in the Caen fighting mostly to gap obstacles and tank traps. (The Tank Museum)

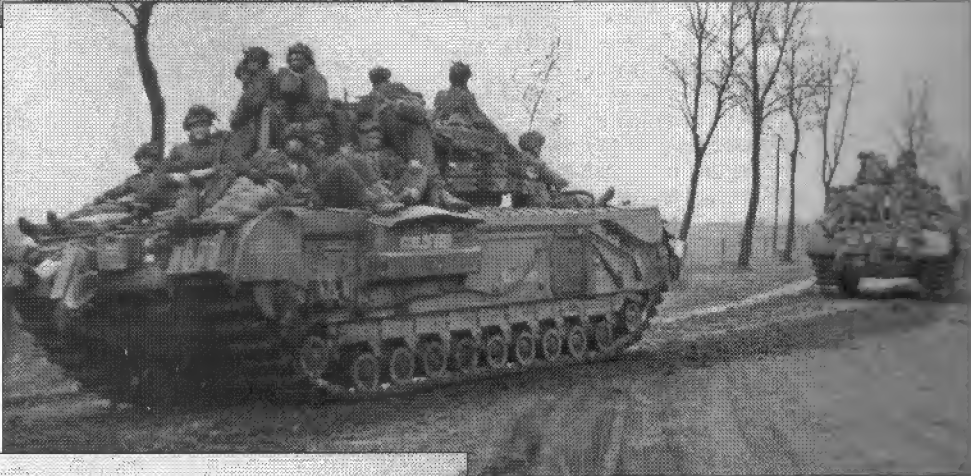
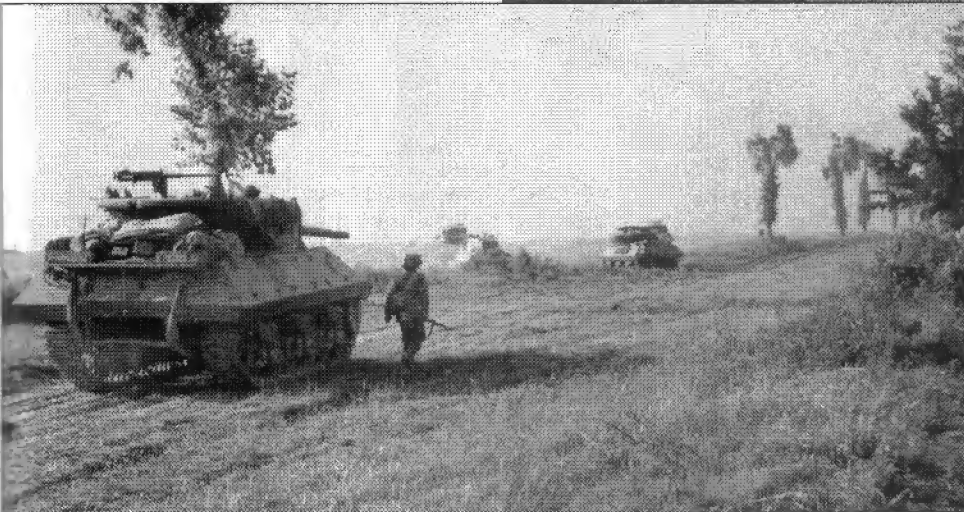
A British M10 Achilles Mk. 2 moves forward between Troarn and Caen during the July fighting. In British service, the M10 was deployed in anti-tank regiments which consisted of four batteries, with 24 M10s in two batteries, and towed 17 pdr. anti-tank guns in the other two. This differed from the American practice of deploying tank destroyer battalions equipped entirely with towed or self-propelled guns. (The Tank Museum)

A Pz.Kpfw. IV Ausf. H of Pz.Rgt. 22 (21.Pz.Div.) knocked out near Lebissey on the northeast approaches to Caen. This photo was taken on 13 July after the British 3rd Division had captured the area. This tank has been well dug in with only its turret showing, a common tactic in the Caen fighting. This view provides a good view of the tank's camouflage painting as well as its tactical numbering. (The Tank Museum)

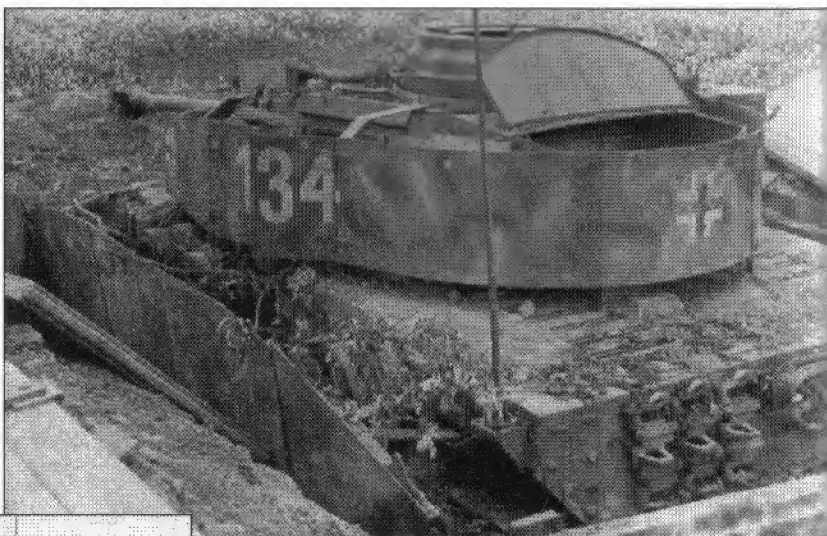
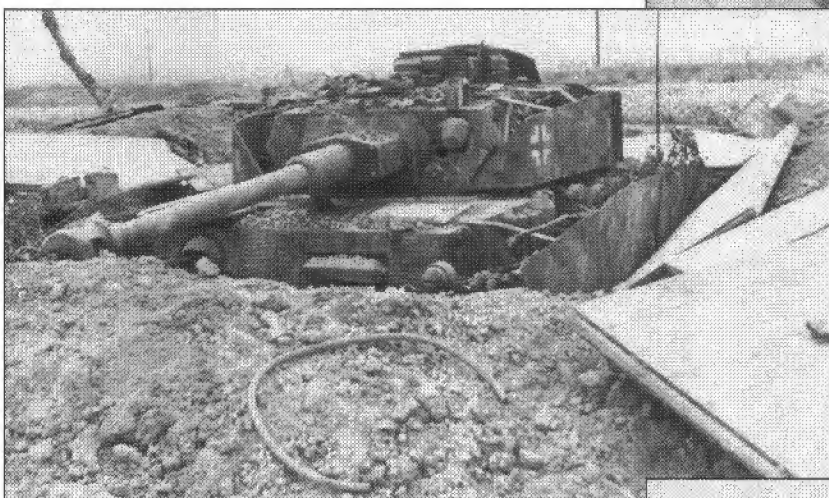
This front view of the Pz.Rgt. 22 Pz.Kpfw. IV shows the cause of its demise, a solid penetration of the turret front to the left of the gun mantlet. Dug-in tanks like this provided a real problem to the Allies, as they were very hard to detect and to knock out. The bellry of the Abaye aux Dames can be seen in the background. The flat terrain in the approaches to Caen allowed the Germans to employ their superior long-range tank firepower to bloody effect against the oncoming British and Canadian armor. (The Tank Museum)

Operation Goodwood on 18 July was preceded by a massive carpet-bombing of the German forces in several key sectors. Panzer units unlucky enough to be in the bomb zones suffered significant losses. Although the aircraft bombs seldom penetrated the armor, their explosive force was often enough to completely flip the tanks on their backs, as has happened to this hapless Panther Ausf. A. (The Tank Museum)

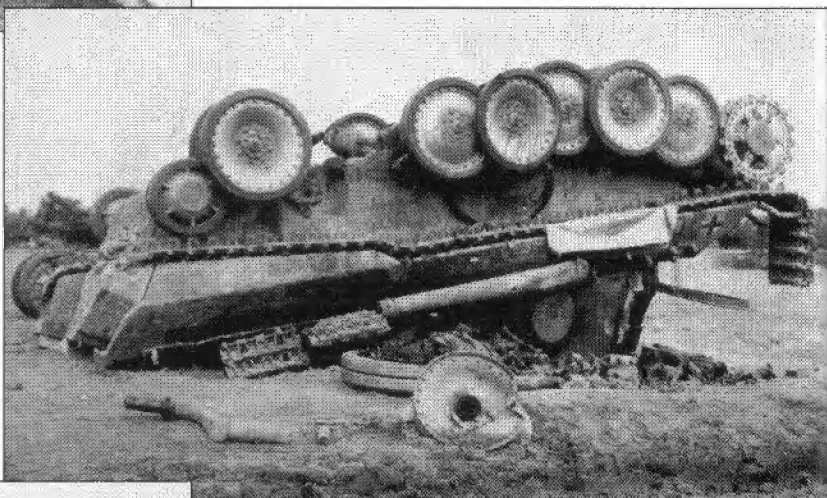
The M7 was named Priest in British service, the nickname stemming from the pulpit machine gun mounting on the right side. This Priest in action near Caen during the 18 July artillery preparation for Goodwood is still fitted with the side panels for deep wading; they were probably retained to provide some modest anti-sniper protection. The standard Royal Artillery tactical marking on the superstructure side, a blue square with a smaller red square in the lower left corner, indicates a howitzer of 3 Battery, the white E4 indicates the 4th howitzer of E Troop. The Priest was gradually replaced by the Sexton in the British army in order to standardize, and some Priests were "defrocked" later in the Normandy campaign to serve as infantry transporters. (The Tank Museum)

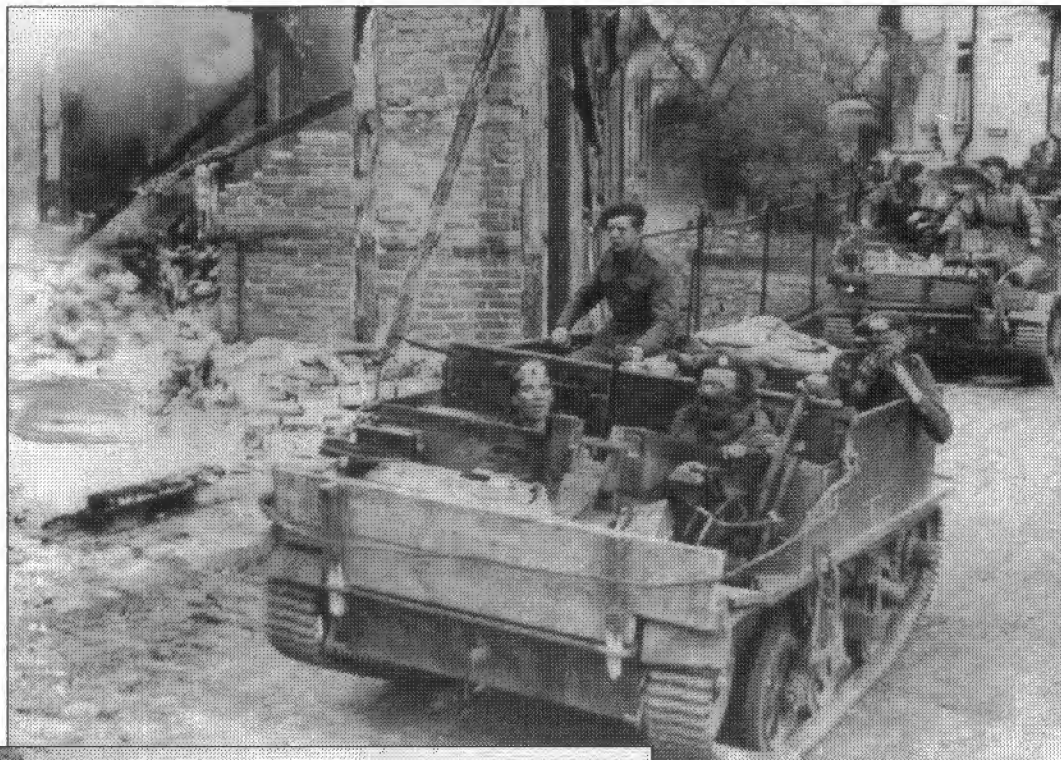
The 6 pdr. anti-tank gun was still in use in Normandy with both the British and American forces, though both were replacing it with the 17 pdr. and 76mm guns. Here one is being towed behind a Loyd Carrier, which was commonly used for this function. The carrier, with a Sherman tank in the lead, is entering Ecouche, probably in August 1944.

Besides being used to create the Sherman Firefly, the 17 pdr. was also used to rearm the M10 Achilles, here a Mk. IIc of the the 117 Battery, 75th Anti-tank Regt. RA, which served with the 11th Armoured Division. The 17 pdr. versions of the Achilles became the predominant version in the later stages of the northwest Europe campaigns. (The Tank Museum)

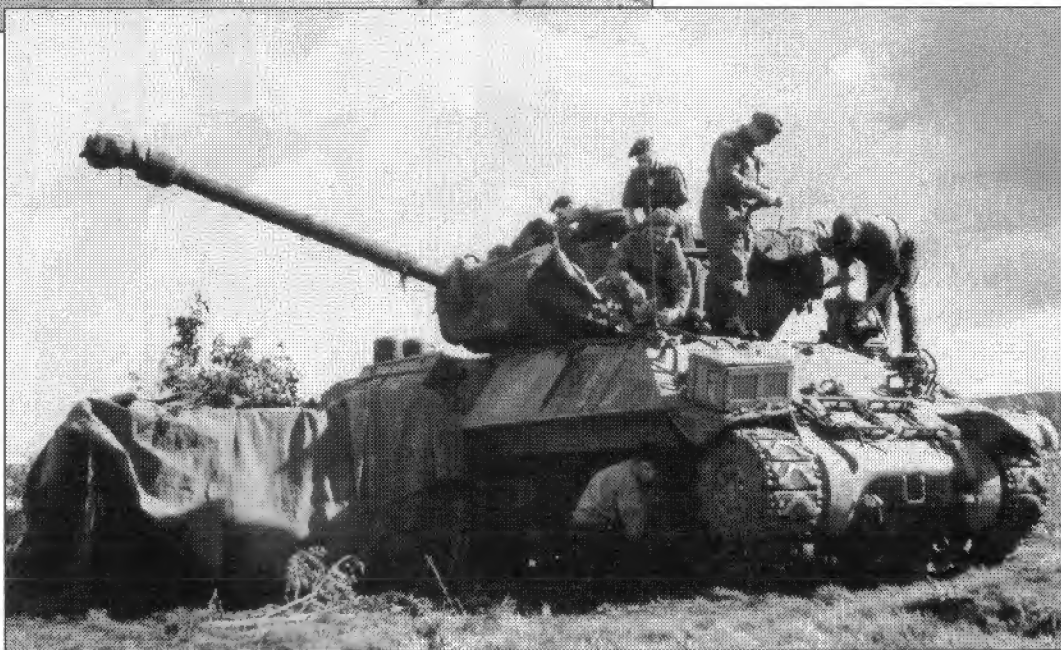
A Cromwell cruiser tank moves up past a column of British infantry. The white tape on either side of the column indicates the advance lines for moving into the jump-off points. These corridors were swept of mines and then marked by the engineers. The British built two categories of tanks, the cruiser tanks like the Cromwell intended for high speed exploitation missions, and the infantry tanks like the Churchill which were more heavily armored and used for infantry support. (The Tank Museum)

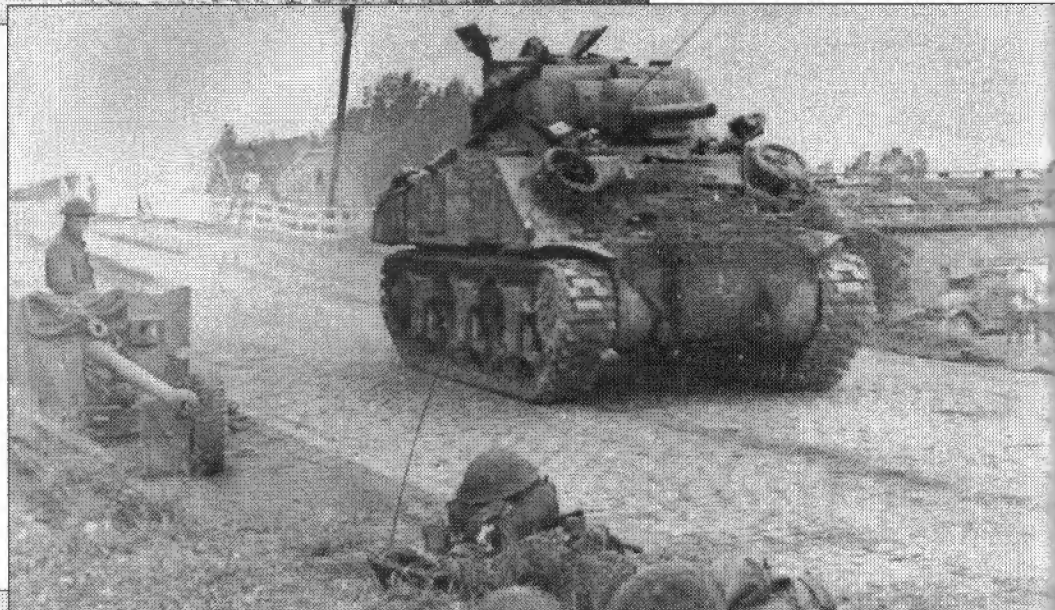
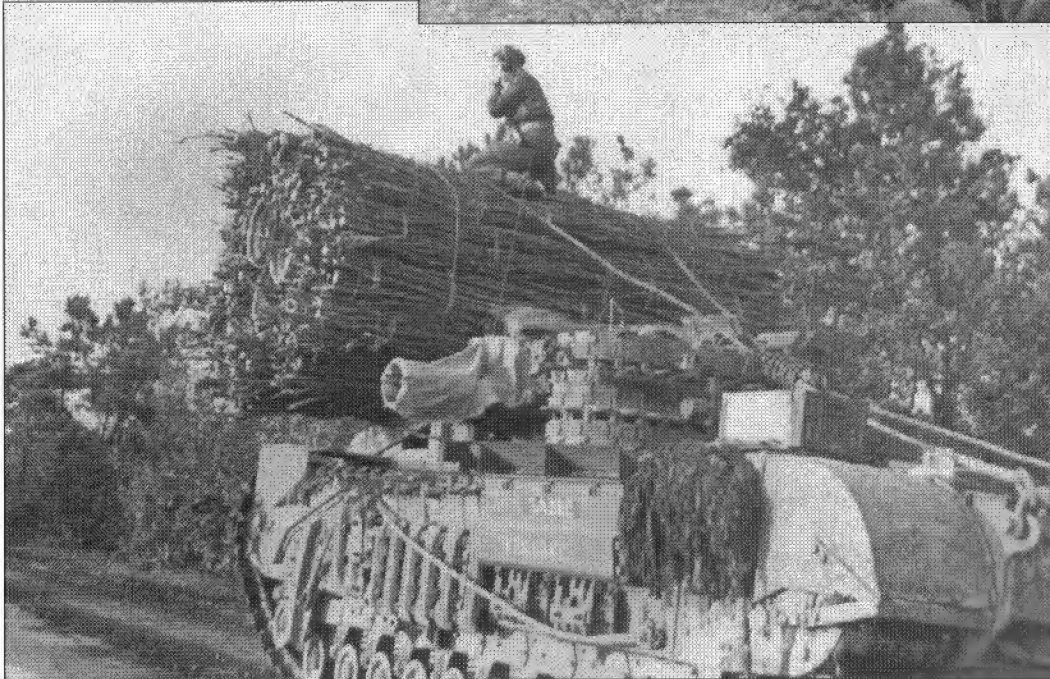
The Churchill AVREs continued to serve throughout the campaign in a variety of functions. This tank, named "Sabre", is being used to carry a fascine for filling anti-tank ditches. Note the Panther track wrapped around the turret front, an attempt to bolster the front protection. (The Tank Museum)

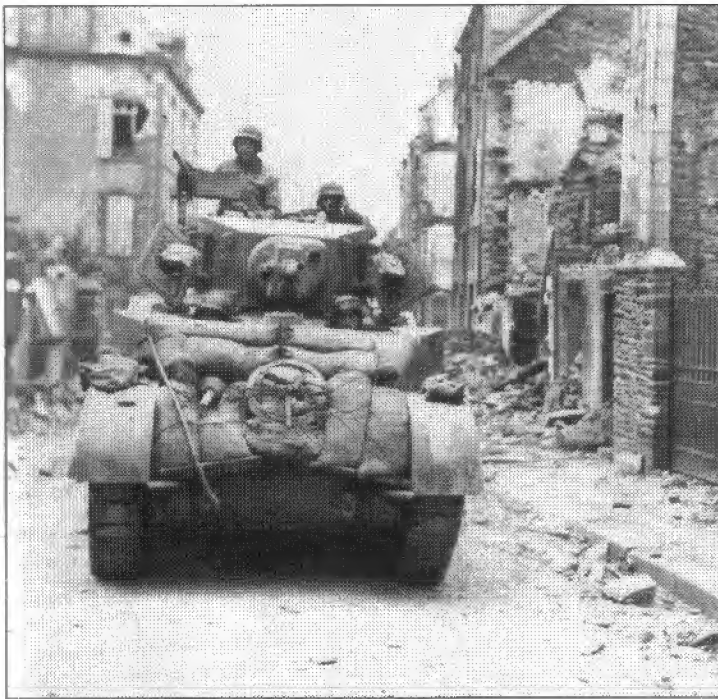
While the British and Canadian forces were enlocked with the German panzer divisions south of Caen, the US Army took steps to break out past St. Lo. Here, a M5A1 light tank moves through the devastated streets of St. Lo on 20 July after the city was finally captured. The first encounters with German panzerfaust anti-tank rockets prompted American tankers to begin mounting sandbags on the front of their tanks as an improvised method of bolstering their protection. (US Army)

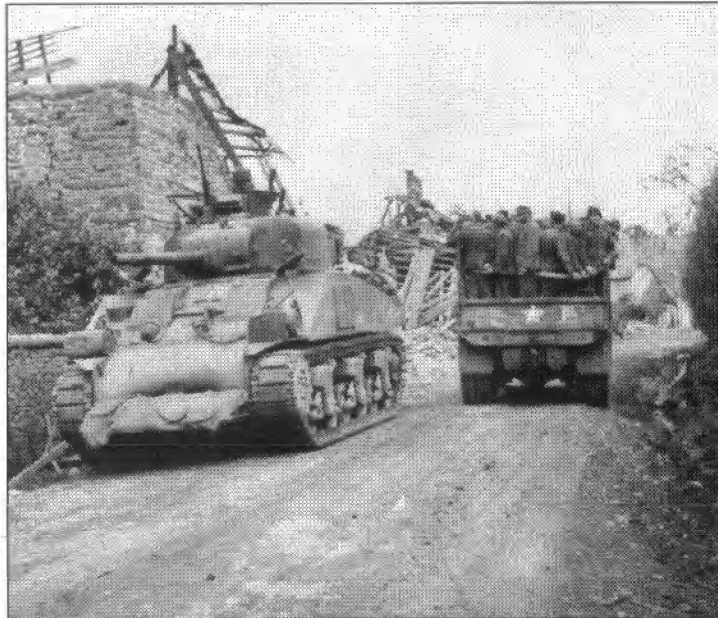
In July, a US Army sergeant named Curtis Culin devised a simple expedient to help break through the hedgerows. A "salad fork" or steel girders was welded together and attached to the transmission housing. When a tank charged the hedgerow with this device on front, it would rip into the roots and punch through them rather than the tank crashing over the top and exposing its thin belly armor to German anti-tank guns. These were called "Culin devices", "prongs" or "Rhinos". When first attached in late July as seen here, they were still secret and so were covered with canvas. (The Tank Museum)

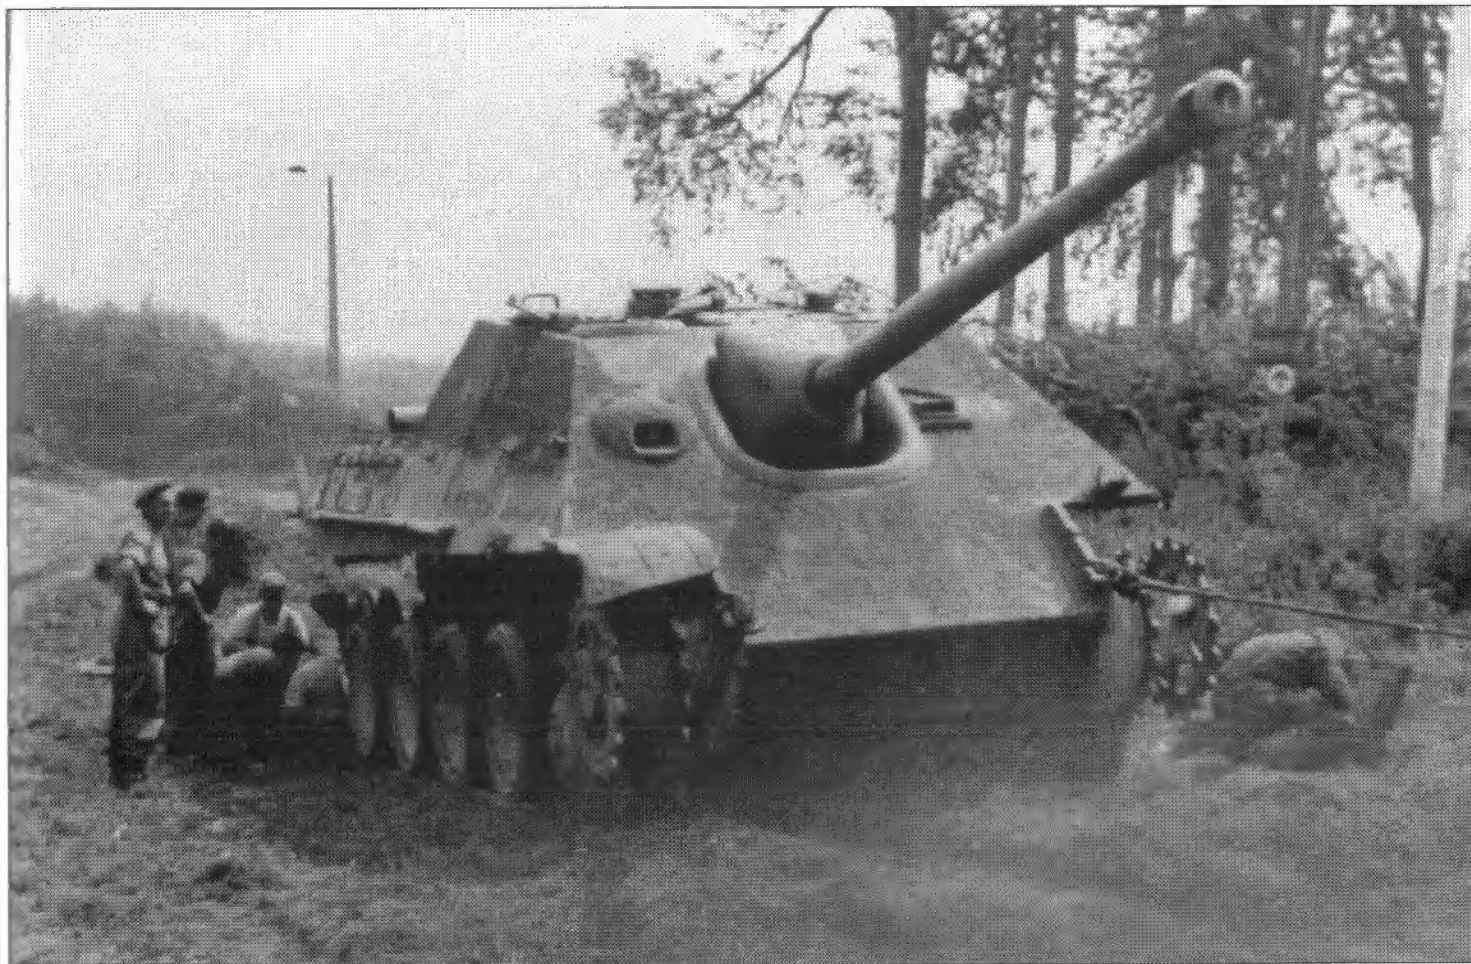
As if the Panther was not deadly enough, the Jagdpanther combined a Panther chassis with an 88mm anti-tank gun. Only a single battalion of these served in Normandy, in the British sector. On 30 July, a squadron of 6th Guards Tank Brigade was ambushed by three Jagdpanthers of s.Pz.Jg. Abt. 654 near les Loges, and about ten Churchills were knocked out in quick succession. The other squadrons brought the three Jagdpanthers under fire, and two were later found abandoned with serious track damage, including the one seen here. (The Tank Museum)

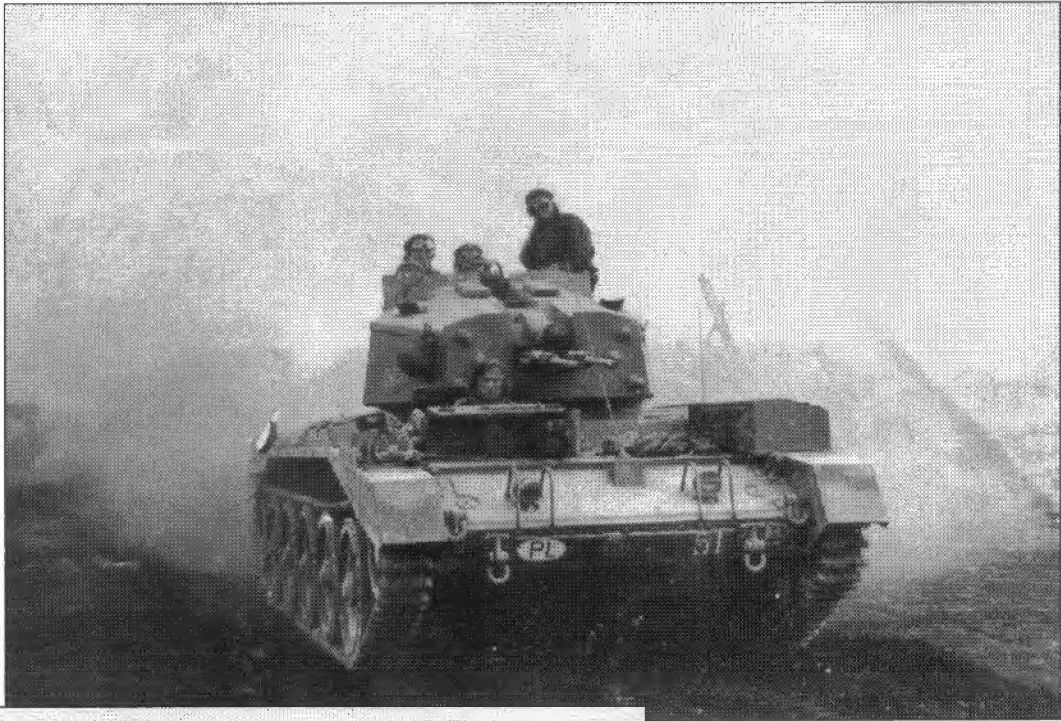
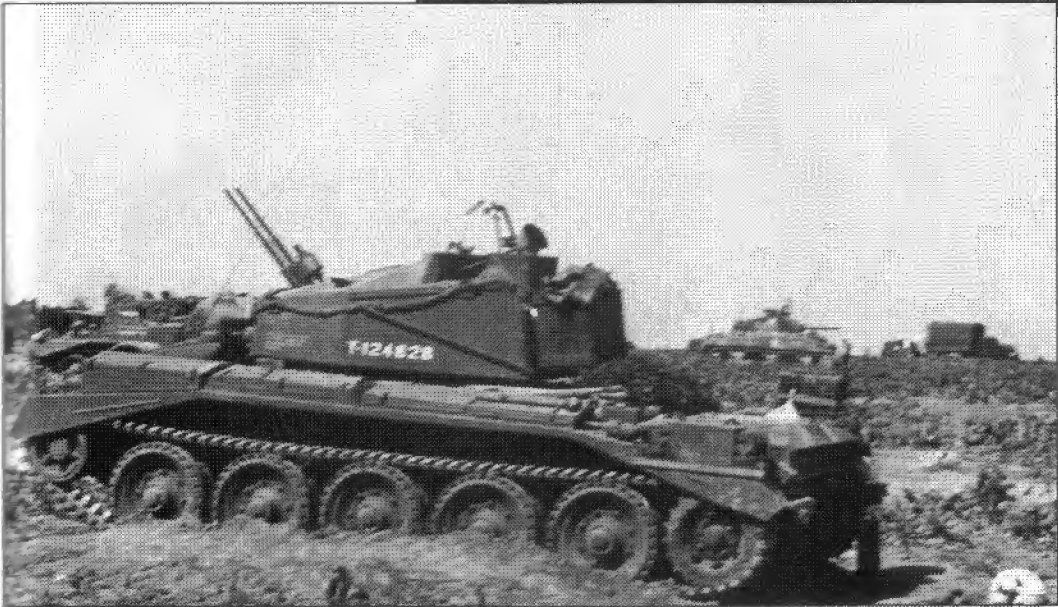
Another view of a Polish Crusader AA tank in the staging areas south of Caen. This view clearly shows the new turret fitted to this variant. The vehicle commander is using the articulated sight that was linked in elevation with the guns. (Pilsudski Institute)
